a Green dam

Background of Problem

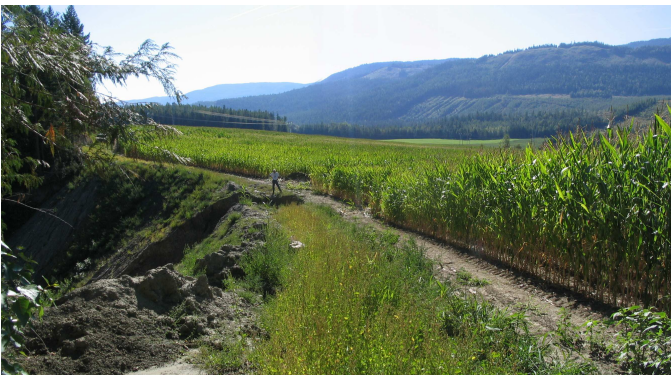
Figure 1 shows the farm owner with his corn field behind him, standing beside the 2006 failure scarp that had just then materialized. At this point the natural creek gully once was about 85m (280ft) wide and 24m (78ft) high. The ground under him is now earthfill.

Figure 1. Initial failure looking East

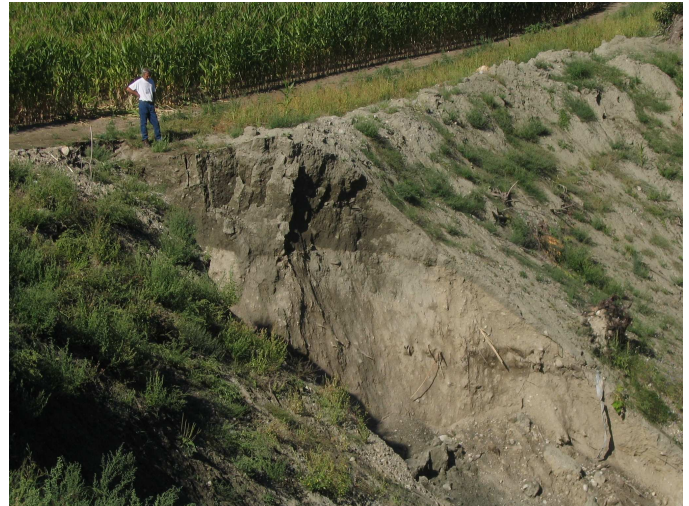
Figure 2. Initial failure looking West

Figure 2 lets us see the two soil types used for filling. The lower fill is a not altogether garbage-free granular material derived from the glaciofluvial spoil from the building sites. The darker upper soil layer is a silty material intended to make for a better growth bed because of its higher moisture retention potential.

The cause of the failure was not due to any deficiency in earthfill stability, but rather, to a most unfortunate malfunction of the automated irrigation system. A mounted rotating watering nozzle set to move in a straight line away from the slope at about 17m/hour (55ft/hour), while delivering a water jet of about 70m³/hour (250gpm), got stuck. Overnight, for about 11 hours, it remained immobilized with its jet impinging on the ground about 30m behind the crest of the escarpment. The large concentrated seepage forces so close to the edge were enough to bring down the slope. This would not have been much of a repair problem for the farmhands if it hadn't been for the position of the failure with respect to fish habitat. Figure 3 makes this clear.

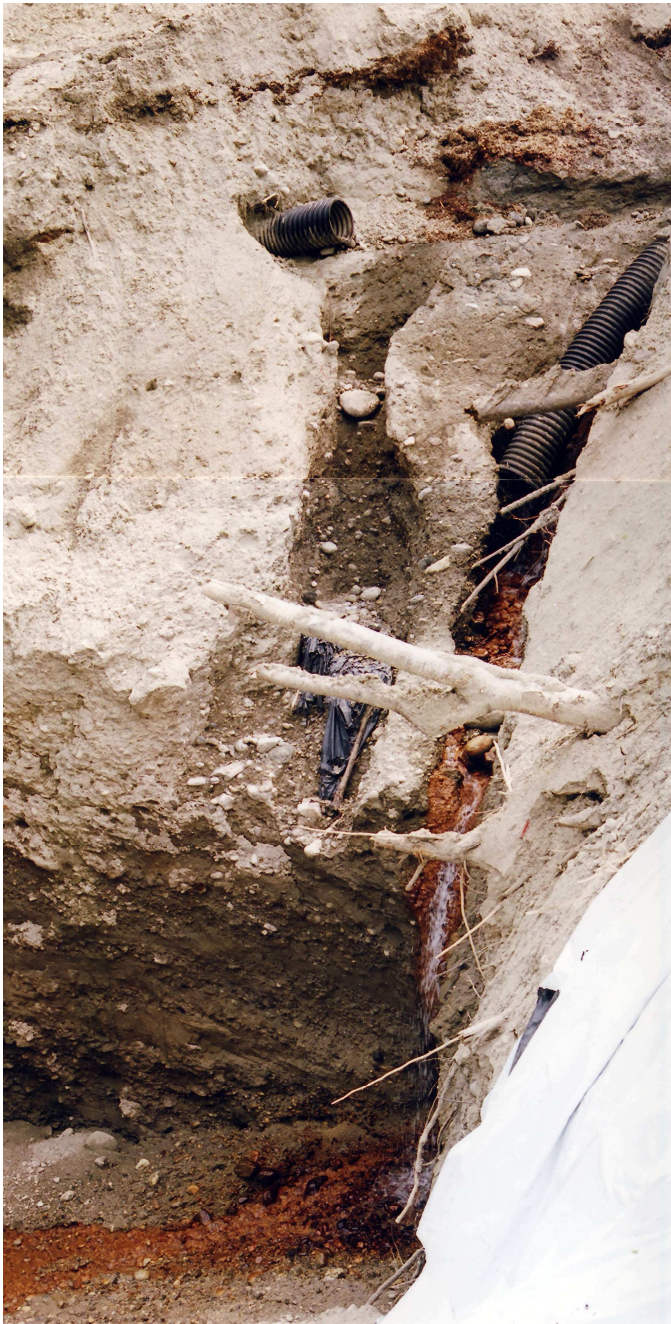
Figure 4 records a sufficient cause for the failure.

Figure 4. disjointed drainage pipe within slope fill

The geology exposed here is imported fill over glacial till and underlain by glaciofluvial soil. The black plastic corrugated pipe is the one carrying the full creek flow which was left in place as a water diversion measure during these repairs. Flow is from right to

left of the picture. As neither end of the pipe joint is damaged and its glacial till bed remains intact, it seems to me that the failure came about as follows: The eastern (picture-left) rill through the till was initiated by some mechanism which pulled the connection loose, leading to collapse of the ground above it. The downward motion of that falling fill pushed the uphill side of the black pipe over the edge of its still-competent bedding. By this stage the full flow disgorged into the slope, resulting in the slope failure. This sequence is suggested by the brown discoloration (likely dissolved fertilizer) of the western rill indicating that shortly after the first leaking formed the eastern rill, the overhead fill collapsed, pulling the pipe apart.

The question of what caused the initial parting of the pipe connection is irrelevant now, but I believe it may have been either due to the excavator bucket tamping, or to water discharge from an open-ended drain gone unobserved.

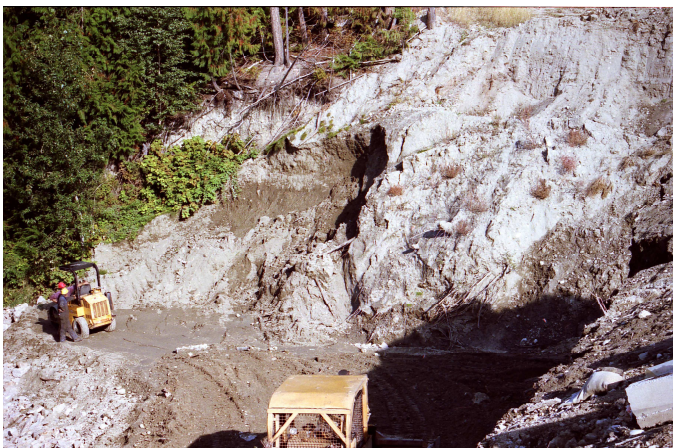
Figure 5. the full construction crew

Figure 5 shows the father & son team discussing their next move. As can be seen here, their progress involved working under a collapsing face so that their safety relied upon the protection of their vehicles, and of course, constant SA - situation awareness.

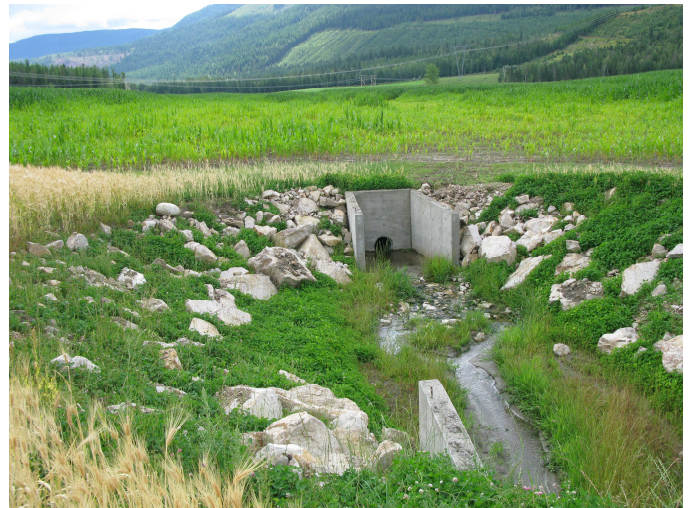
Figure 6 is a view (looking SE) of the 450mm (18") plastic pipe carrying the stream flow as it enters the little surge pool upstream of the dam.

Figure 6. flow from piped stream entering surge pool

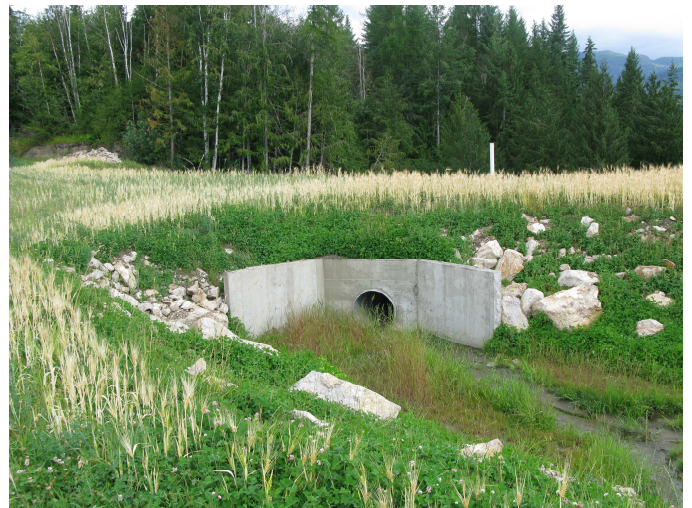
Fig. 7 shows the concrete intake structure where a 914mm (36") galvanized steel pipe carries the flow through the little earthfill dam.

Figure 7. intake structure

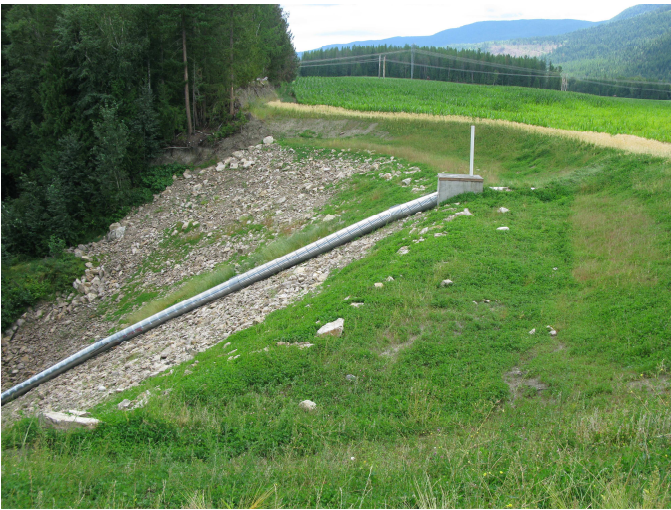
Figure 8. downstream view looking East

Figure 8 was taken from the left abutment and shows the downstream side of the dam and the discharge pipe running down the slope.

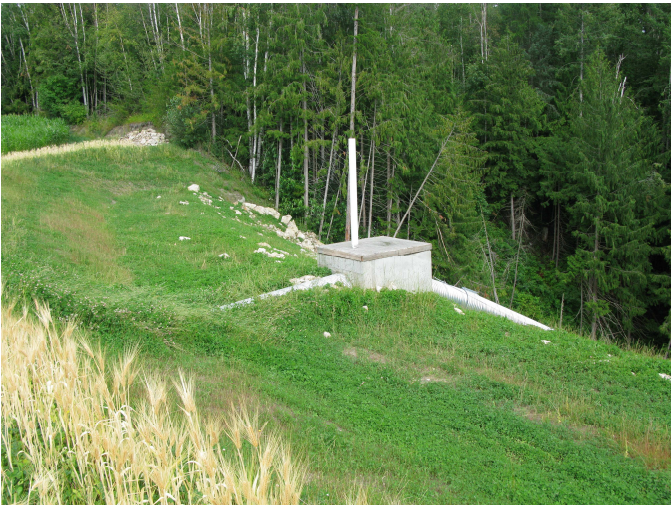
Figure 9 is a view from the crest looking towards the left abutment and showing the downstream berm as well as an air-ventilated hut. This small concrete chamber contains the hydraulically designed concrete forming required for making the transition between the larger intake pipe and the smaller, but very steep outlet pipe.

Figure 9. pipe transition housing

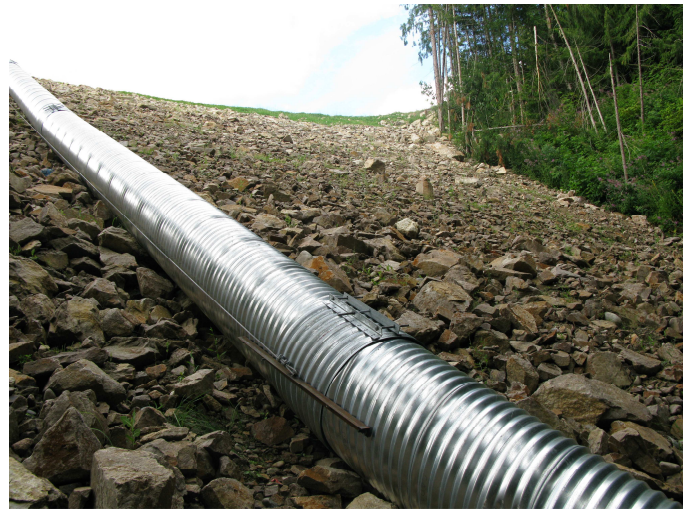
Figure 10 shows the “belt and braces” approach to pipe connections of the steeply inclined outlet pipe.

Figure 10. belt & braces

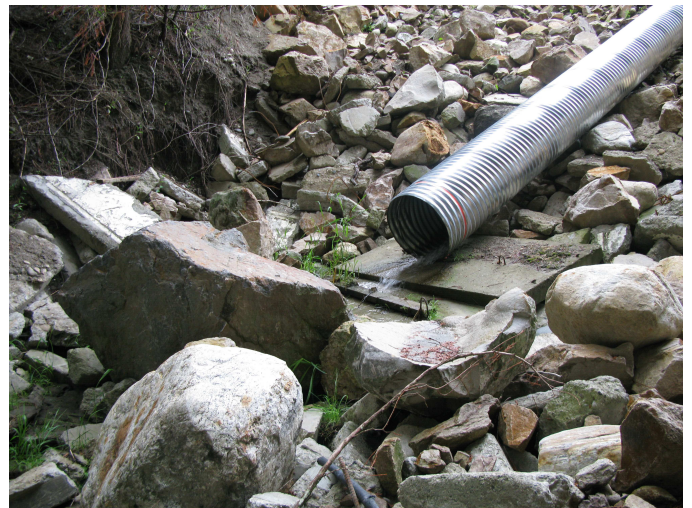
Figure 11 shows how a pre-existing partially buried natural rock block was used as a means to safely dissipate the hydraulic energy (impulse- momentum principle) at the toe of the slope.

Figure 11. energy dissipation at toe

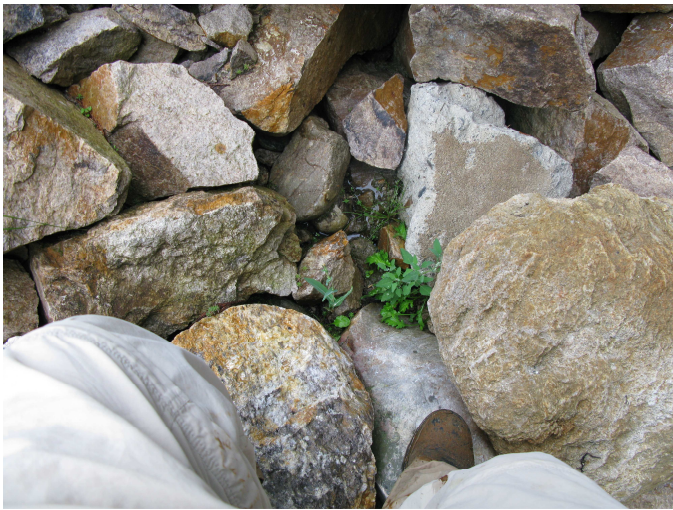
Figure 12 shows that the treatment of open-ended drainage pipes of various size and origin had been successfully drained to the slope face. The clarity of the water indicated that retrogressive erosion was not weakening the slope.

Figure 12. seepage clear & controlled

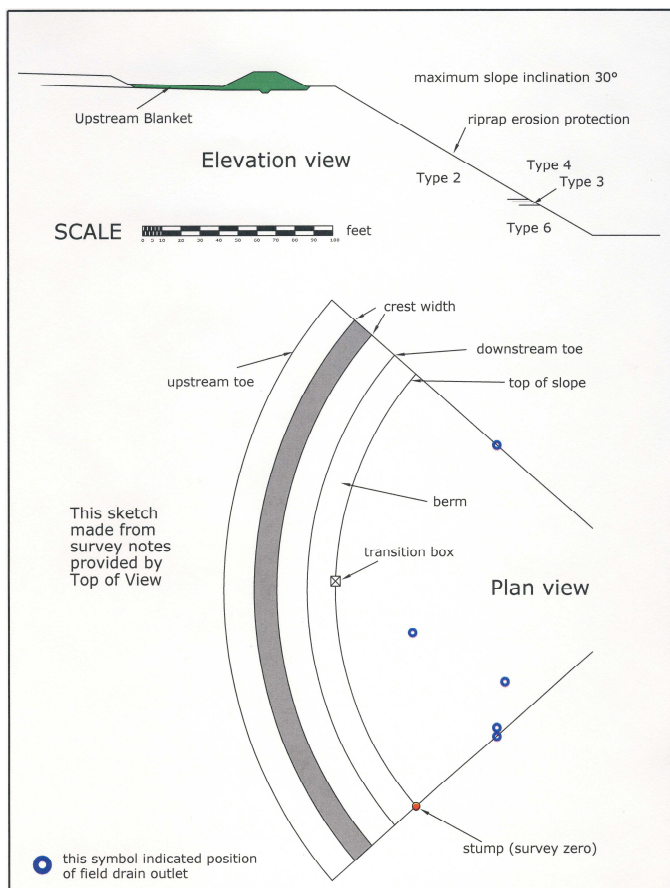
Figure 13 is an “as-built” sketch showing the main parts of the complete works.

Figure 13. as-built sketch
