Interpretation of Piezometric Traces by h-Method

William E Hodge

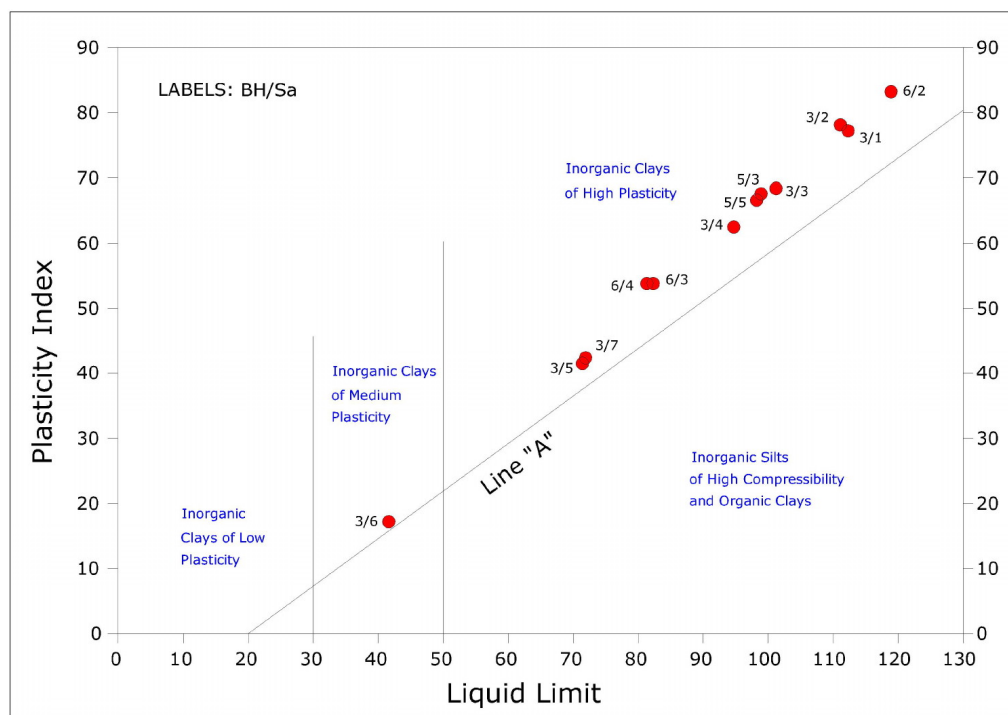
Figure 3 Plasticity Chart

The results of the 12 Atterberg Limit tests from undisturbed sampling in BH3 and BH6 are shown in Figure 3 plotted on the standard Plasticity Chart devised by Professor A. Casagrande. All but one of these points fall well into the zone of "inorganic clays of high plasticity". The fact that these data pairs are sensibly parallel with the Line "A" indicating these clays have a common geological origin.

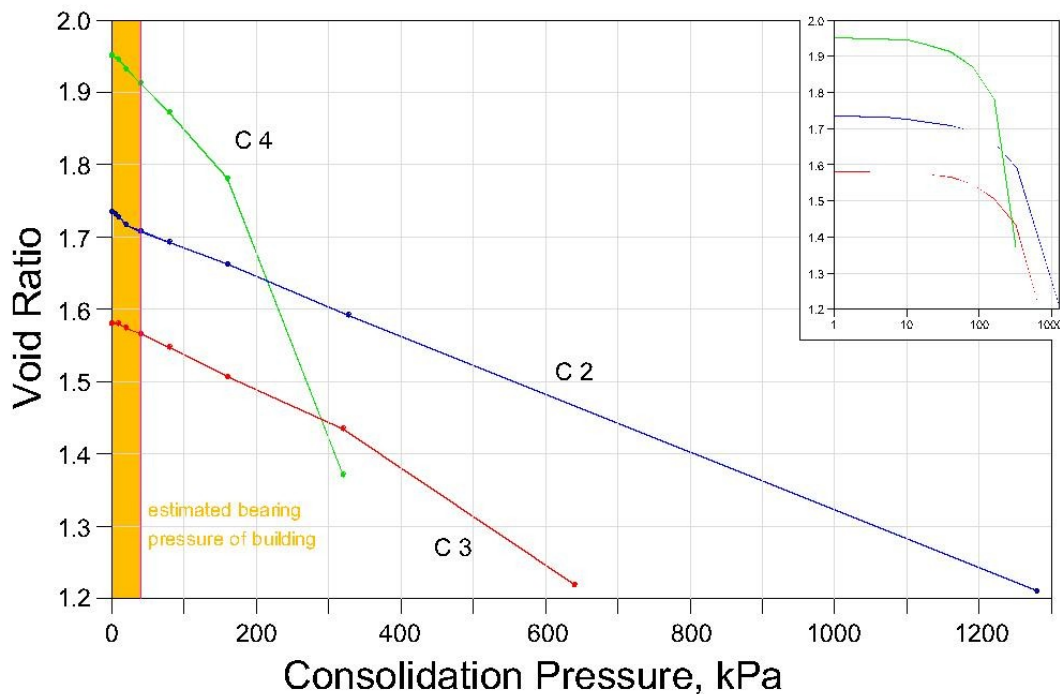
Figure 4 Oedometer test results

The laboratory results from the Oedometer testing of 3 specimens recovered from BH6 are plotted on the chart shown in Figure 4.

The readings suggest that soil sample C2, recovered from the upper crust shows evidence of having been virtually lithified after being baked in the sun to an extent that all pore water evaporated from the particles; a process which brought high interparticle suctions into play. As explained in Ref 1 such forces pull individual particles closer together and result in soil cohesion. In the case of coarse silt and fine sand this type of cohesion (apparent cohesion, C_A) is lost if the soil is re-wetted or becomes totally dry. However, in the case of plastic clay, as drying progresses to the point where *adsorbed* water is lost - thereby allowing physiochemical contact between adjacent clay surfaces - this cohesive bonding will remain should the soil later become (water-) saturated. This latter form of cohesion, is what accounts for the stiffness (terracotta-like) of this specimen.

C3, from 1.5m deeper into the crust, would have been somewhat insulated from solar energy and consequently experienced a lesser degree of desiccation: it appears to have been pre-consolidation to just over 300kPa. C4, from just below the crust, shows a clear indication of pre-consolidation to about 150kPa. Both these levels of pre-compression are far above the estimated cumulative building pressure (45kPa) subsequently to be exerted on the foundations. This average level of construction loading is shown as the highlighted narrow strip to the extreme left of the chart.

The void ratio data shown in Figure 4 indicates that a chunk of this soil would be more water than mineral particles: C2, 64% water and 36% solids; C3, 61% water and 39% solids; and C4, 66% water and 34% solids

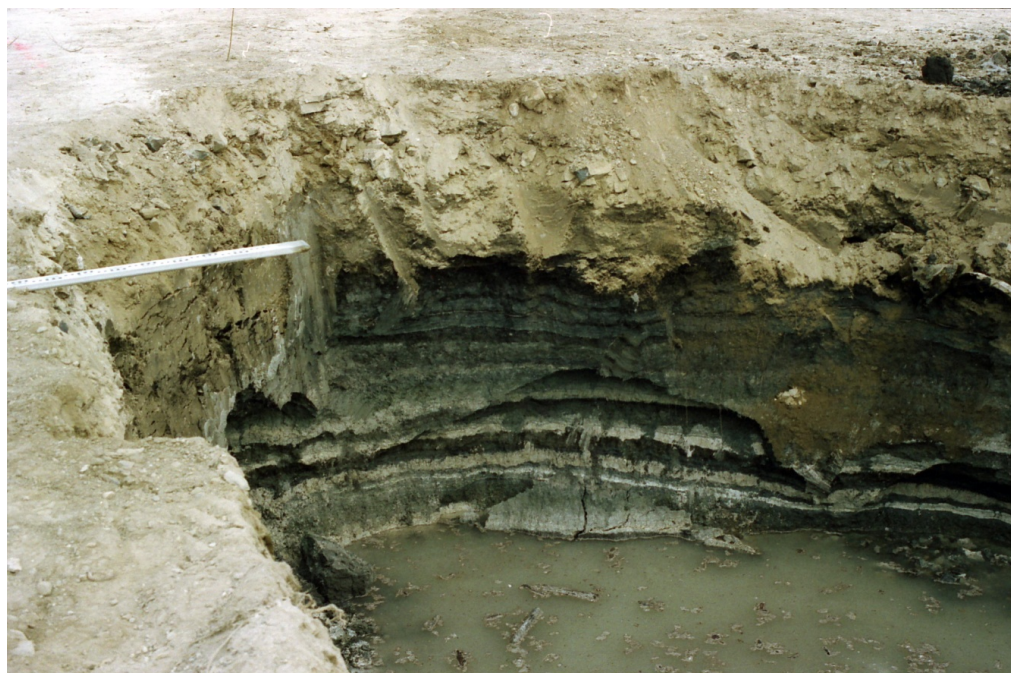
Figure 5 Postglacial Deposits beneath Site Fill

The interlayered weak and compressible materials overlying the crust, which are somewhat bluish in colour (not exposed to the atmosphere), were subsequently deposited in periglacial conditions. These soil types are similar to those common in the Canadian North. The presence of volcanic ash layers within this stratum helps fix the time of deposition at sometime following the eruption of Mount Mazama which occurred about 7,700 year ago. This ash was blown around in the Vernon area for up to 3,000 years after the eruption, and this accounts for more than one seam of ash being present at the site.

There are basically four distinct strata beneath this site: The post-glacial natural surficial materials shown in Figure 5 underlying the old site grade fill, can be seen to contain multiple layers of weak and compressible materials including very soft clay, peat, ash, and shells, and as such must be ruled out as a possible foundation layer on which a building might be supported. Likewise, at the other extreme, the highly competent glacial drift body at a distance of 36m (118ft) below ground level is simply out of reach in practical terms. That left only the desiccated "crust" and the underlying normally consolidated lacustrine deposits as the foundation options.

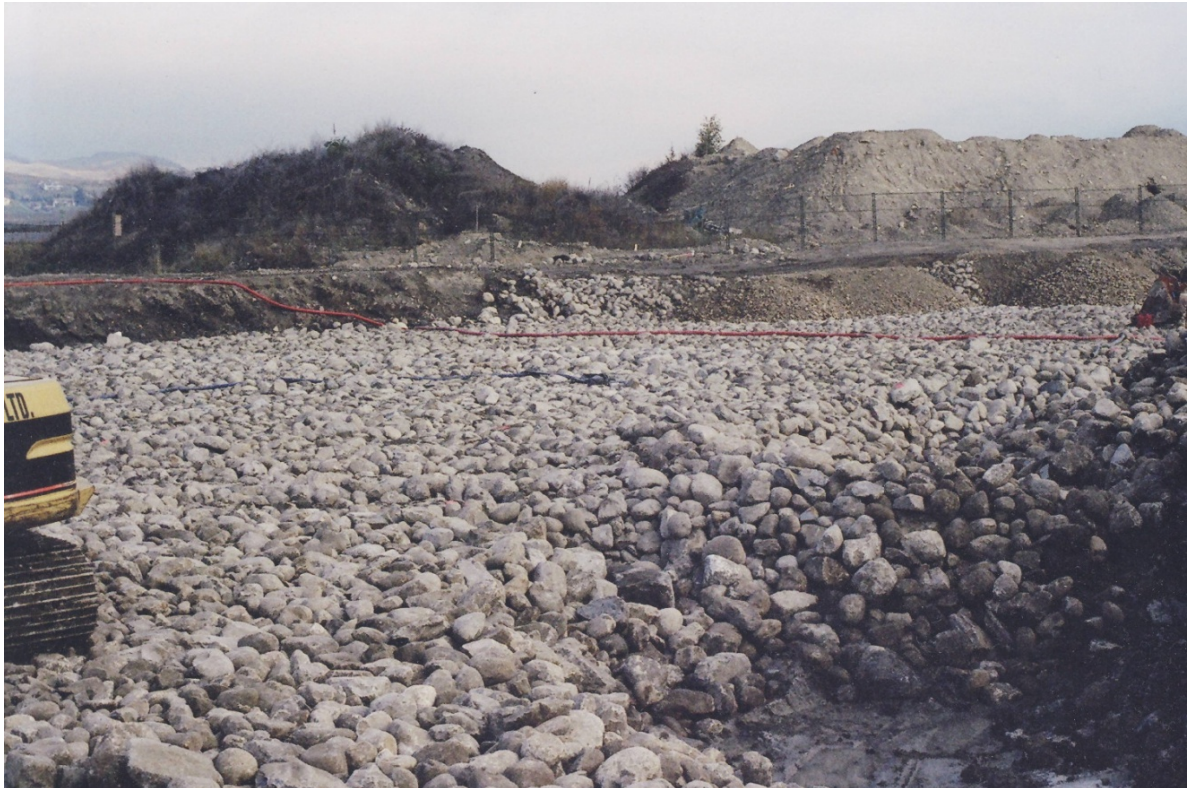
Figure 7 Backfilling the Foundation Excavation

Figure 7 is a photograph taken as the foundation excavation was being backfilled. The body of the picture shows the boulder layer almost complete. The top of the "crust" is still exposed at bottom right, beside the cut slope. On the far side of the red hose pipe, stockpiles of the cobble fill material may be seen. And, further back, beyond the boundary chain-link fence, the pre-load fills intended to prepare the foundations for what was shortly to become the Lake City Casino are obvious.

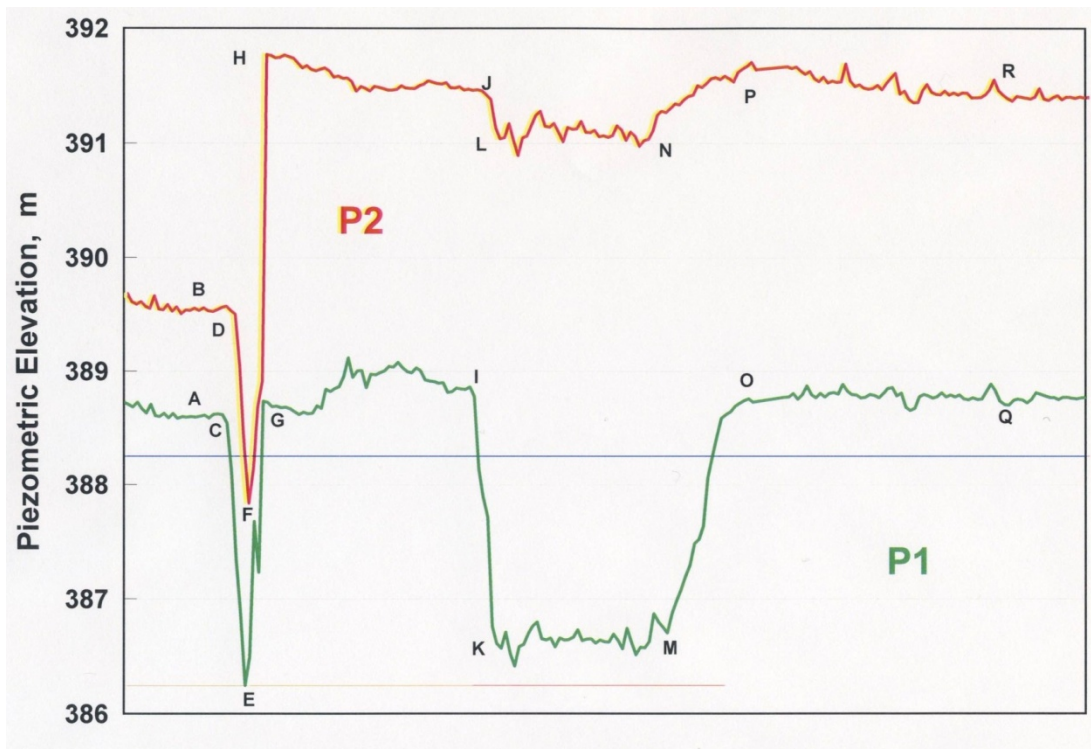
Figure 9 History of Ground Water Responses to Construction

The groundwater pressures measured by the two piezometers throughout the construction period from July 2005 to August 2006 are shown plotted in Figure 9.

The trace for the shallower instrument (7m depth) is labelled P1 and that of its partner (19.9m deep) is labelled P2. The natural water table is shown as a blue line at Elevation 388.2m; during the two periods of site groundwater drawdown the temporary water table is shown in the bottom left as a purple line. The vertical distance from the prevailing water table to a point on either trace is the numerical value of the *epwp* at that time and that piezometer.

The sixteen Upper Case letters (A to R) shown against the traces are listed in Table 1; these are used as signposts to specific events such as groundwater drawdown. The numerical value listed against each letter is the *epwp* (in metres of water) available for that point at that particular time. Incidentally, part of this *epwp* is attributable to the artesian pressure gradient.

These plots start on July 14th, three days after installation, and show that over the next six or seven weeks the *epwp* due to cavity expansion (a consequence of pushing the piezometer bodies into the ground) dissipates and both readings tend towards their minimum values [A,B].

At the beginning of October 2005 [C,D] the first significant scheduled construction activity began: this was the excavation of the weak and compressible natural materials beneath the building footprint in order to remove those postglacial soils and expose the competent desiccated clay crust. In the event, the contractor opted to dewater the excavation because the wet spoil being hauled from the site would have spilled from the trucks and muddied / soiled the highway pavement. By December 1st the hole had been backfilled with boulders and cobbles and the water table allowed to return to its natural elevation.

P1 responded to this as expected, with a 23kPa pore water drop consistent with the amount of burden removed [E], and subsequently returning to an appropriate level [G] as the hole was refilled with granular soils and then flooded again. But the recorded behaviour of P2 was most surprising: between [D] and [F] it dropped by 16kPa, and then, by December 1st rebounded by 39kPa to [H] (an abrupt increase of 3.93m). This was a serious departure from expectations and suggested that following the shock of drawdown the crust proved too weak to fulfil its load-carrying function, and was just passing the increasing construction loading onto the softer sensitive fine grained stratum below.

As may be seen in Figure 9, for the next three months until the second drawdown, starting March 3rd, the traces each show a different profile : P1 is jagged [G to I], whereas P2 [H to J] is muted. This is because the former is in the desiccated crust with easy access to drainage, whereas the latter resides within the inorganic clays of high plasticity where venting of *epwp* is dependent on consolidation.

The P1 trace is more irregular than that of P2. This is because P1 is embedded in a more elastic soil than its partner which is experiencing reconsolidation. So P1, during this period, shows the net *epwp* caused by loading added to the ground surface, minus its concurrent dissipation by seepage flow. The leading edge of each peak represents a situation when surface loading exceeds the rate of drainage; the trailing slope indicating where pore pressure dissipation is faster than the effects of ongoing construction.

At the beginning of March [I,J] the local water table was drawn down for a second time, on this occasion to enable installation of underground facilities "in the dry". The response of P1 was as anticipated: the readings during this period [K, M] all fell by the amount of the drawdown (2.0m) in acknowledgement of the new local water table, but while still retaining the proper levels of *epwp*, about 0.3m. As for P2, it did not follow the example of P1 inasmuch as to recognize the full extent of the water table drop.

Comparing the shapes of the two sets of readings during the following three month period, while both instruments are obviously responding to the same stimuli, their treatment of those pressure changes was somewhat different. For the first half of this time [L-N] P2 shows more pronounced peaks and valleys than its partner. The reason for this seems to be that in the beginning P2 records the full extent of the changing *epwp*, but with time, this intensity becomes subsumed beneath its ongoing background consolidation. The response of P1 [K-M], on the other hand, seems to be a more natural matter of gaining some load while at the same time losing some *epwp* to the effort of drainage.

At the end of May [M,N] pumping ceased and the natural water table restored itself by the beginning of August [O,P]. Thereafter, to end of construction in September [Q,R], the foregoing relationship between P2 and P1 appears to fit the data well, with the peaks being more prominent in P2 while consolidation continues at a rate suggesting it would take a matter of years to exhaust its remaining pore pressure potential. P1 just drifts on at no more than 30cm above its artesian level.

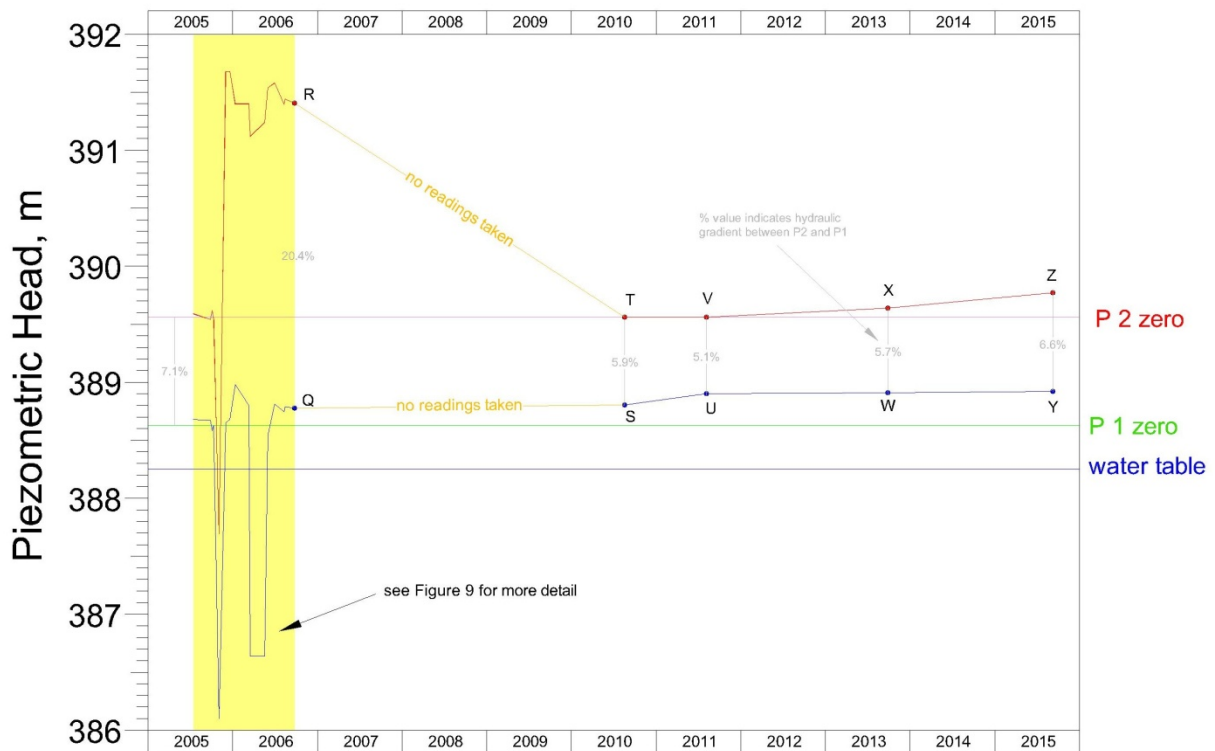
Figure 10 History of Piezometer Responses from 2005 to 2015

For the 3½ years following the end of construction no further piezometer readings were taken. Then starting in late summer 2010 a series of four single pairs of data points were read over the next five years. Those readings are shown on Figure 10 together with the water table level and the artesian elevation for the two piezometers.

This plot shows that in the meanwhile the consolidation of ground around P2 had fully resolved itself and the pressure reading [T] was at its minimum artesian level. But this was not the case with P1 where the pressure at [S] was 0.17m above its artesian zero. And looking back to Figure 9 it can be seen that P1 had not lost any potential in the 3½ years since [Q].

Back in November 2005 at the time when the crust failed (under the strain reversal of the first drawdown) the hydraulic continuity of the groundwater flow from P1 to the water table was damaged/impaired to the extent that it required the expenditure of more *epwp* to maintain the flow through the upper crustal soil. Consequently, the pressure around P1 needed to be permanently increased by 1.7kPa, thereby reducing the original artesian pressure gradient from 7.1% to 5.9%: a reduction to the original beneficial upward Seepage Force of 16.7%.

P1's subsequent increase [S-U] is attributable to the building of a Casino on the neighbouring property immediately to the north of this site. P2's escalating readings [Y-X-Z] are probably due to further development of the area at a somewhat more remote proximity. What these few readings suggests is that, just like the off-site pulses discussed earlier (see Figure 8), these pressures were transmitted as *epwp* through the water-phase, and had their origin in relative motion in the foundation strata beneath the nearby buildings.

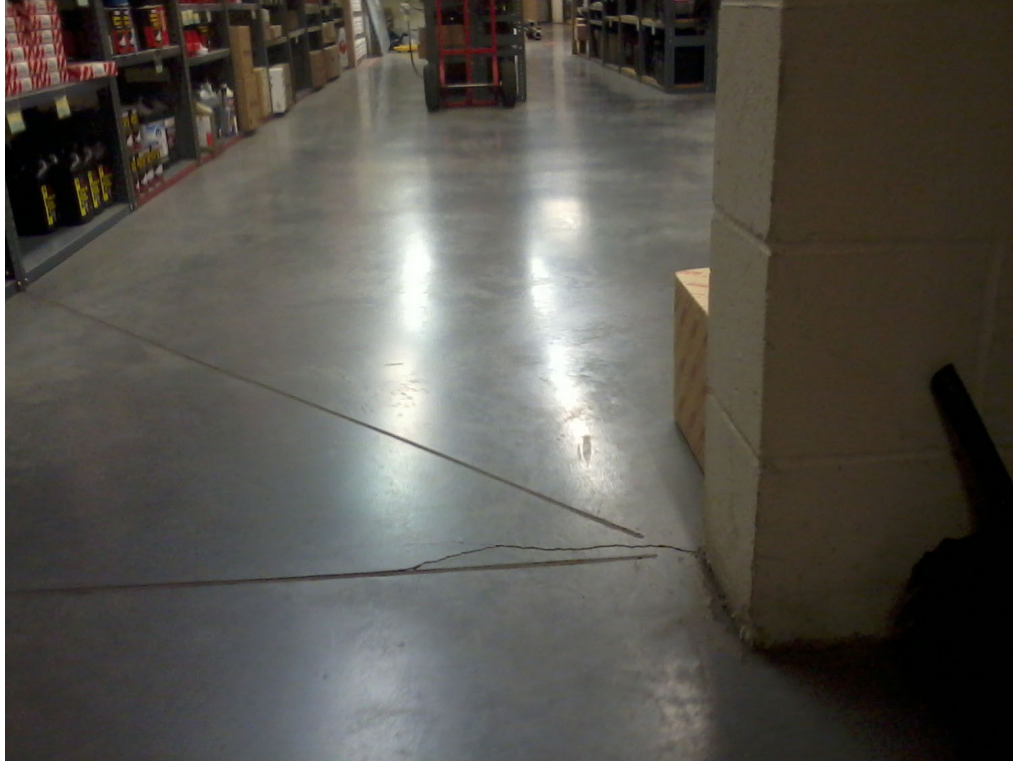
Figure 11 Only Floor Crack in Entire Concrete Slab

Little needs to be said in this regard other than to draw attention to the evidence offered in Figure 12. This photograph, taken after 10 years of commercial operation, shows the only crack, about a metre long, in the entire 7,000 square metres of concrete flooring. Incidentally, that single imperfection was caused by a machine bumping into the column from which it emanates while the concrete was yet green.
