# **Pore Pressure Monitoring of a Novel Foundation**

**Written and illustrated by: William E Hodge**

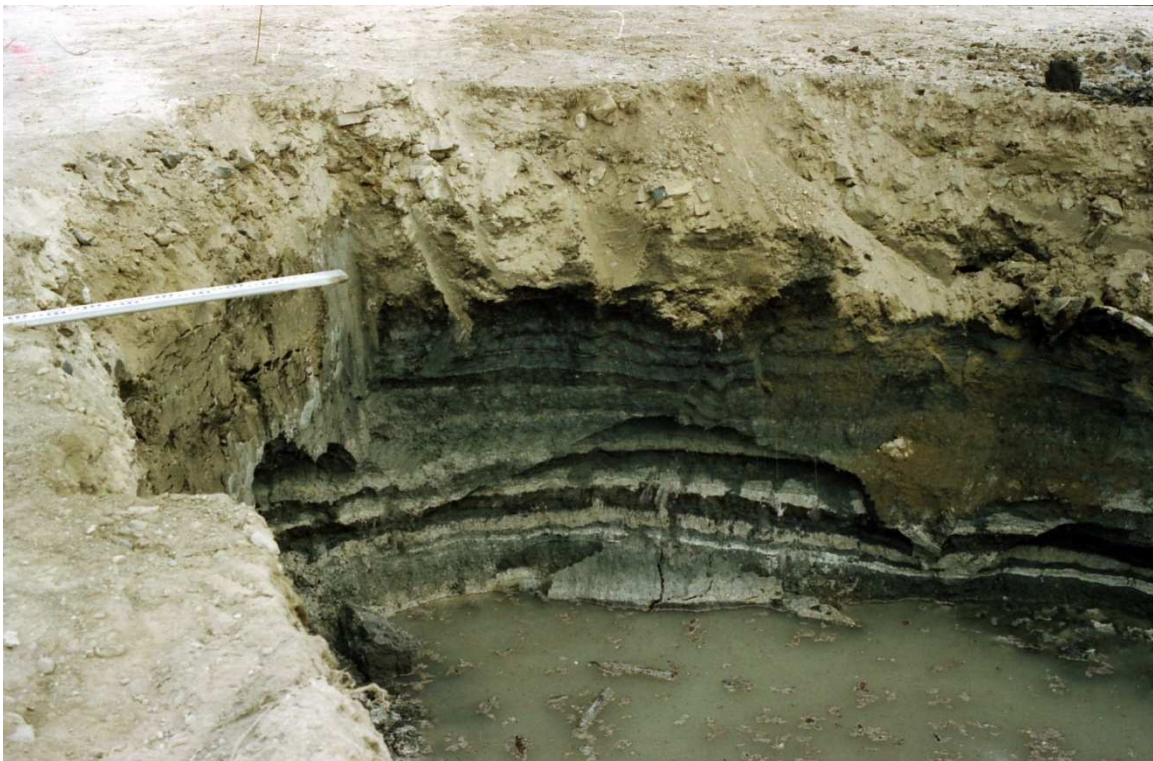
**Figure 2** Interlayered very soft clay, peat, ash, and shells (~1m visible) beneath imported fill

Figure 2 is a photograph of the natural soils underlying the old site grade fill and shows this stratum to contain multiple layer of weak and compressible materials including very soft clay, peat, ash, and shells, such as to rule it out as a possible foundation layer on which a building might be supported.

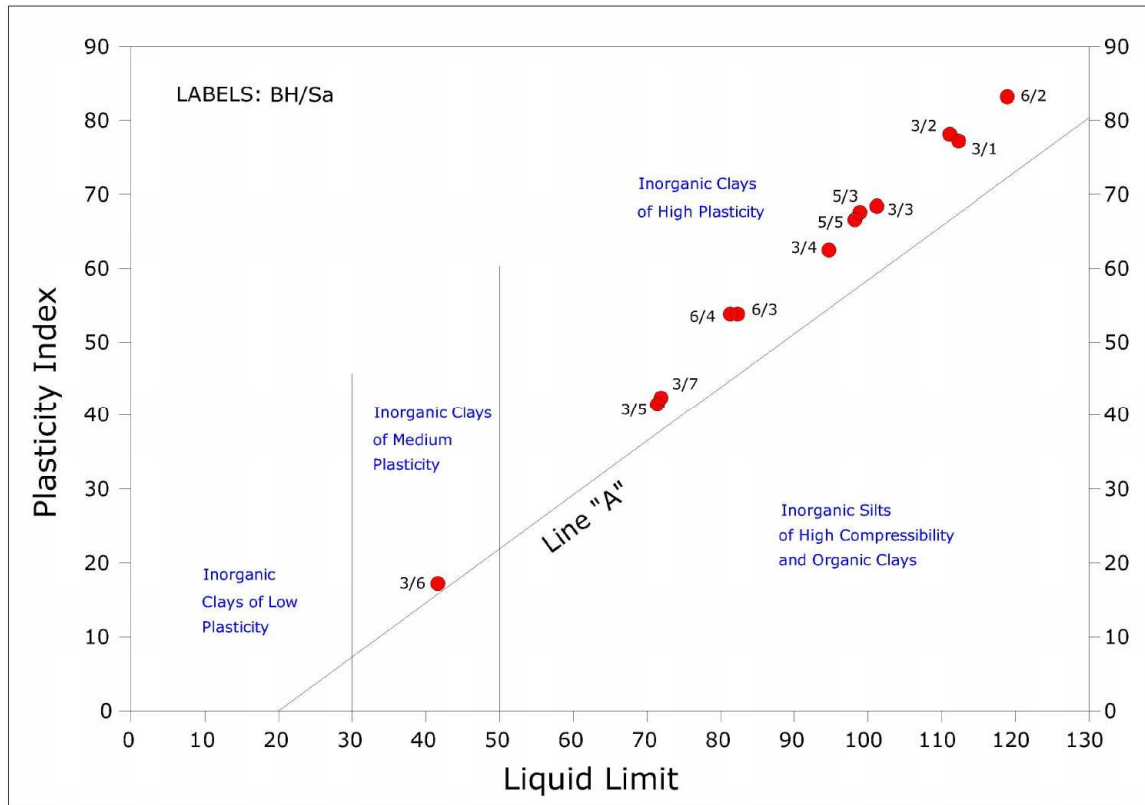
**Figure 4** Plasticity chart

The results of the 12 Atterberg Limit tests from undisturbed sampling in BH3 and BH6 are shown in Figure 4 plotted on the standard Plasticity chart devised by A. Casagrande. All but one of these data pairs fall well into the zone of "inorganic clays of high plasticity. The fact that these data pairs are sensibly parallel with the Line "A" indicating these clays have a common geological origin.

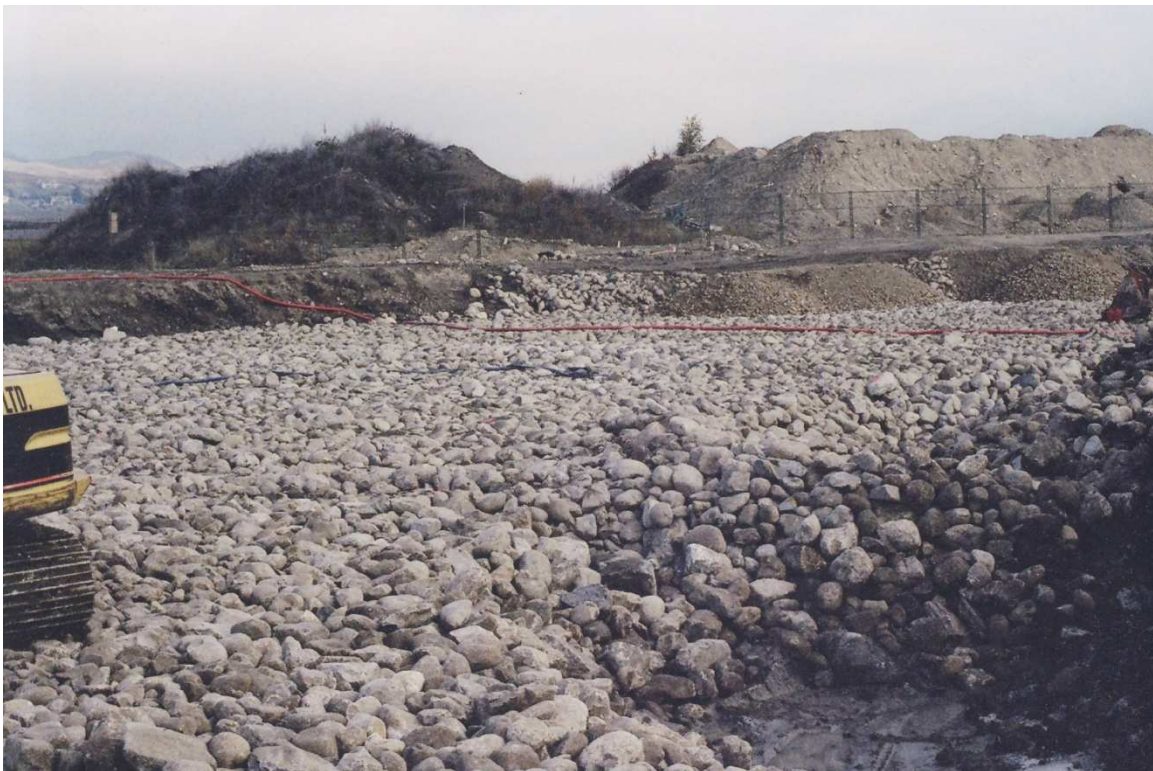
**Figure 7** Backfilling the Foundation Excavation

The bottom layer of boulders was selected and approved by my inspection at the quarry. After this layer was in place the overtopping cobble material was selected in the same way, on the basis that the cobble sizes were such that they would not fall into the boulder voids. The additional constraint on the cobble gradation was that normal sand and gravel fill would likewise not enter the cobble voids.

Figure 7 is a photograph taken as the foundation excavation was being backfilled. The body of the picture shows the boulder layer almost complete. The top of the "crust" is still exposed at bottom right, beside the cut slope. On the far side of the red hose pipe stockpiles of the cobble fill material may be seen. And, further back, beyond the boundary chain-link fence, the pre-load fills intended to prepare the foundations for what was shortly to become the Lake City Casino Vernon ("Casino") are obvious.

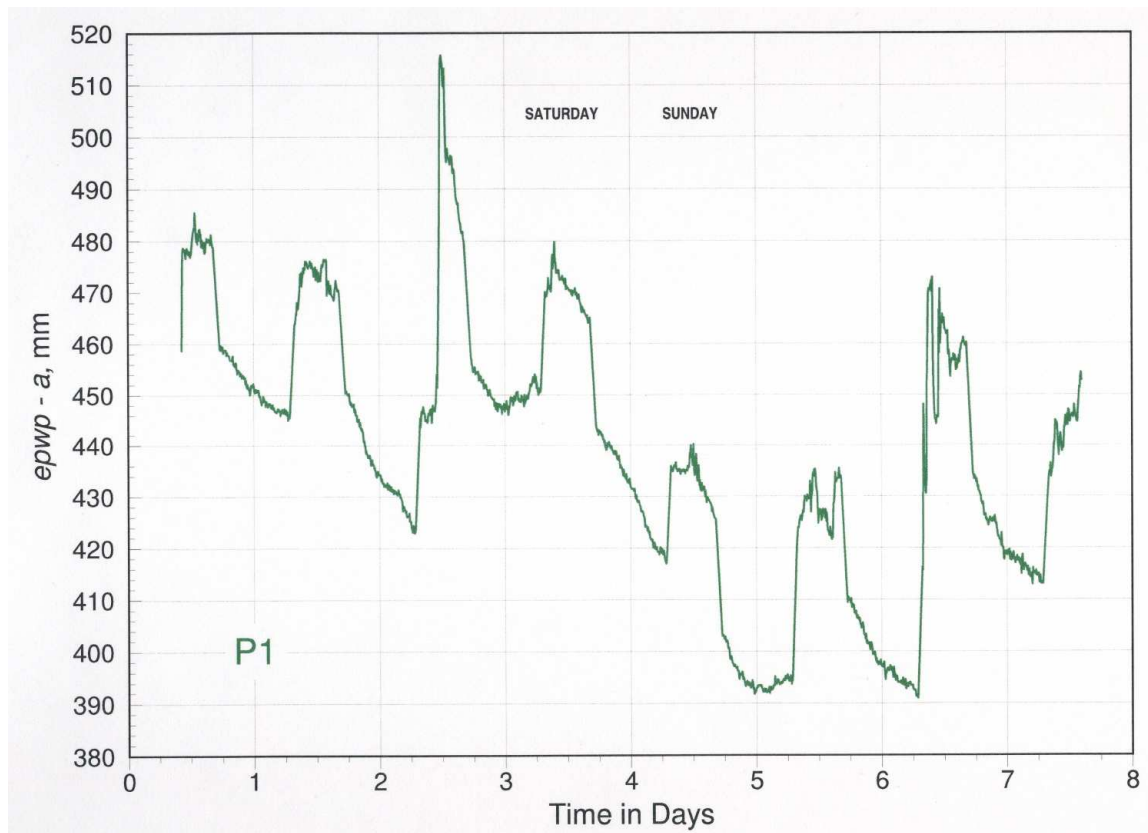
**Figure 8** Extraneous ground water pressure pulses

Before getting into their responses to construction activity it is worth looking at how they behaved to an extraneous off-site repetitive event. Figure 8 shows the water pressure history recorded by P1 at 6 minute intervals over a period of seven days. It shows a weak pressure pulse of relatively constant intensity (20mm of head) entering the groundwater every morning at 7am and leaving at 5pm that same afternoon.

The pulses are cleanest on the weekend when activity at ground level was minimal. The pressure spikes superimposed on the repetitive pulses during working days are attributable to the ever-increasing ground level loading, due for example, to concrete placement and building material arrivals.

What I find of great interest is the fact that during the quiet interval between the Saturday and Sunday pulses a gradual dissipation of water pressure can be clearly discerned. And, this observation alone confirms the axiom that when/where excess pore water pressure, that is, pressure in excess of hydrostatic, exists within a saturated soil seepage flow must also be taking place.

So, what these few readings suggest to me is that, just like the off-site pulses discussed earlier (see Figure 8), these were transmitted through the water-phase, and had their origin in relative motion in the foundation strata beneath the Casino. It is likely significant that that structure was built following preloading of its foundations, and without removal of the upper weak and compressible strata, contrary to the procedure used at our site.

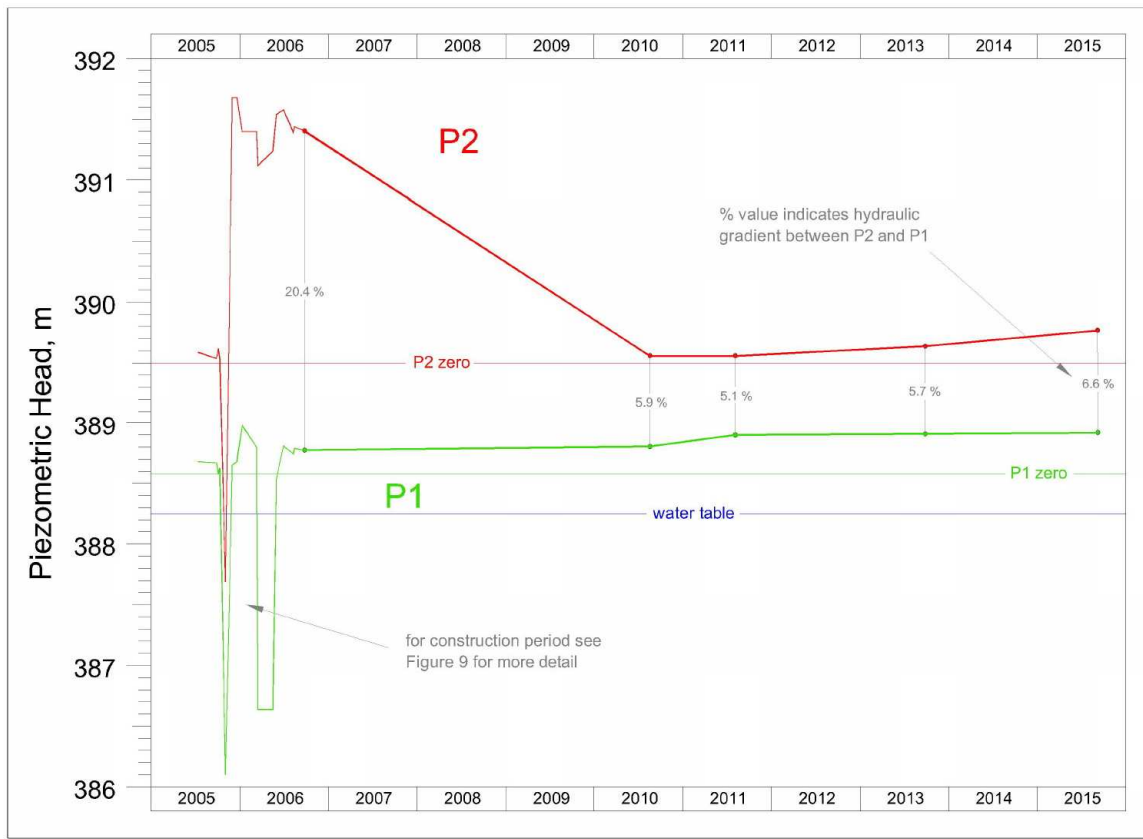
**Figure 11** History of piezometer responses from 2005 to 2015

Over the years following construction, whenever I passed through Vernon, I made a point of dropping in at the building to check the foundation slab for any signs of concrete cracking. On those occasions, if I had a readout device with me, I would check the piezometers too. Those readings are shown on Figure 11. Here the time scale shows dates, while the piezometric heads are plotted directly against elevation. This latter scale differs from the one I used in Figure 9 and was chosen in order to separate the data points for clarity. Also shown on Figure 11 is the water table and the zero (artesian) elevation for the two piezometers.

I was struck by the fact that both instruments were registering an increase in pore pressure. When I visited the site to read the 2015 data I showed the 2013 plot to the Owner (Marty Steele) and asked him if anything had been added to the site loading which could account for the water pressures being now above their pre-construction levels. His immediate response was "Could it have to do with the construction of the Casino?" This rather large structure was built on the neighbouring property to the north sometime after completion of work at this/our site. I cannot think of a better explanation and therefore I have adopted his.
