a Green dam

Background of Problem

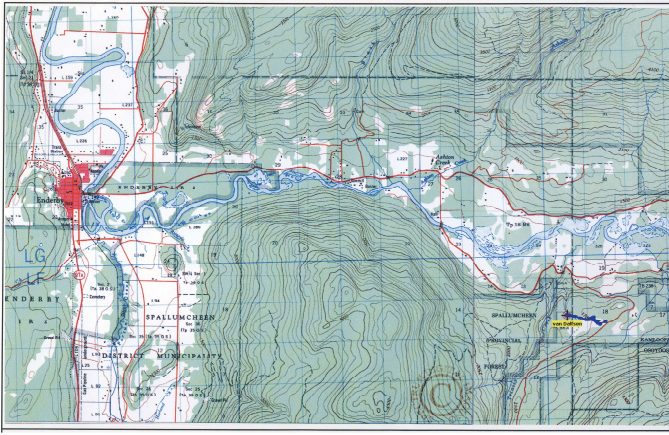
Figure 3. site location & the Shuswap River

The cause of the failure was not due to any deficiency in earthfill stability, but rather, to a most unfortunate malfunction of the automated irrigation system. A mounted rotating watering nozzle set to move in a straight line away from the slope at about 17m/hour (55ft/hour), while delivering a water jet of about 70m³/hour (250gpm), got stuck. Overnight, for about 11 hours, it remained immobilized with its jet impinging on the ground about 30m behind the crest of the escarpment. The large concentrated seepage forces so close to the edge were enough to bring down the slope. This would not have been much of a repair problem for the farmhands if it hadn't been for the position of the failure with respect to fish habitat. Figure 3 makes this clear.

Department of Fisheries and Oceans (DFO) determined that fish habitat had been affected along Trinity Creek, a tributary of Shuswap River by the sediment entering from the canalized creek; the fine silt and clay fraction from the growth layer had reached this popular sport-fishing stream. The farmers were thereby exposed to a criminal charge based on an environmental offense - such being the Rule of the Land.
